# Manhole Inspection Summary

Manhole # S39CC\_018MH

**Inspection** ☐ Is Incomplete Rating: **3) Fair**

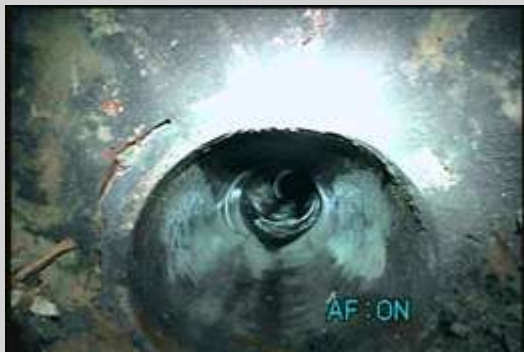
12 O'Clock Outflow

8 in. Circular Gravity Sewer  
Pipe Out @ 12 O'Clock

Pipe Material: **Clay** ☐ Pipe Lined

Invert Depth: **9.54** (ft.) Flow Characteristics: **None**

Deposits: ☒ None ☐ Mud ☐ Sludge ☐ Debris ☐ Grease

Infiltration: **None** Pipe Seal Cond: **Unknown**
